Assessing the Freshwater of Eastern Charlotte

Assessing the Freshwater of Eastern Charlotte:

2016

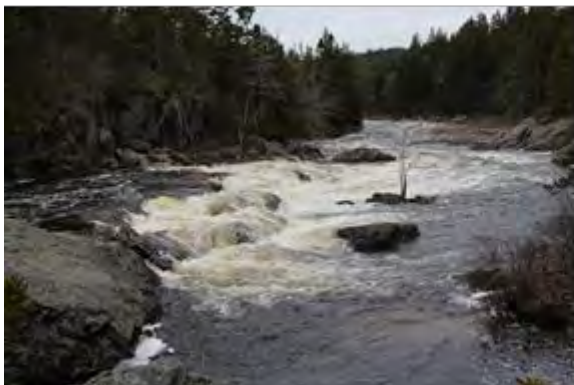
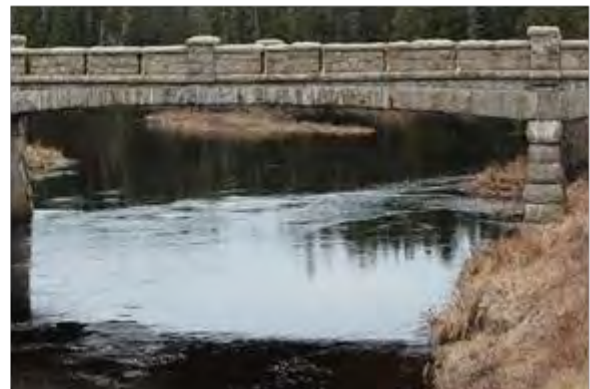
Figure 3: Lepreau sample sites (upstream on left).

Water temperatures in the Lepreau River were very similar to those reported in 1994 to 1996, and did not exceed 24°C. Dissolved oxygen content was sufficient to sustain aquatic life ranging from 6.2 to 13.4 mg/L, with the exception of low levels recorded at both sites in mid-June of 2014; possibly associated with equipment calibration issues. Overall, pH levels improved slightly compared to 20 years ago (Table 2), but remain low ranging between 4.7 and 7.4 upstream and 5.0 and 7.2 downstream. These low pH levels sustained throughout most of the sampling period are of concern for aquatic life but most likely a result of the area’s geology. Turbidity levels were low at both sites throughout the sampling period and did not exceed 1.2 NTU. Aside from improvements in pH levels, the Lepreau River appears to have had little change in water quality in the last 20 years.

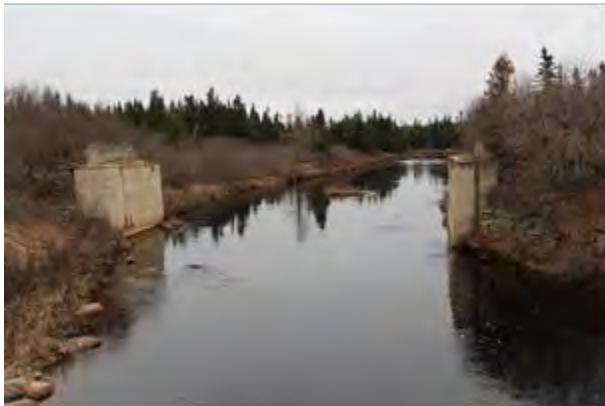
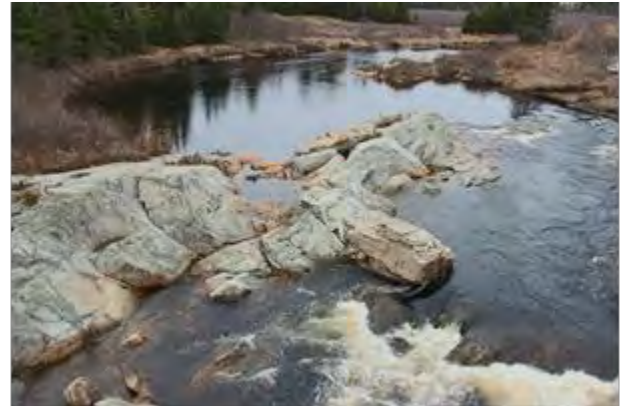
Figure 4: New River sample sites (upstream on left).

Water temperatures at both sites were consistent with 1994-1996 recordings and did not exceed 23.1°C. Dissolved oxygen levels significantly improved since 1994-1996 (Table 2), and when considering all sampling years (1994-1996 and 2014-2015), DO levels were lower during the early summer months. The pH levels remained the same as in 1994-1996, still dangerously low at times, especially at the upstream site which ranged from 4.3 to 6.7. Turbidity levels remained low, as was seen in 1994-1996, and only exceeded 1 NTU following precipitation events in mid-September 2014 and late October 2015.

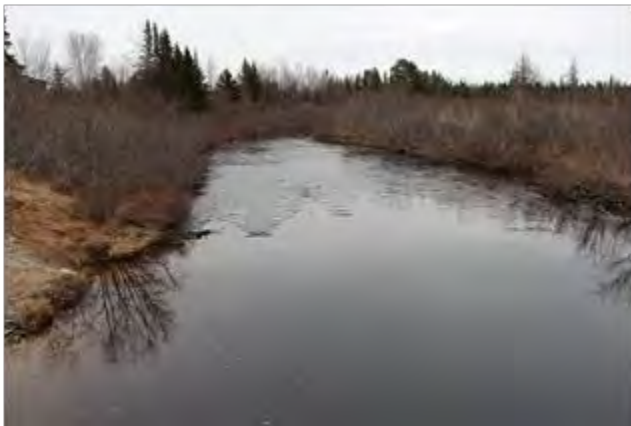
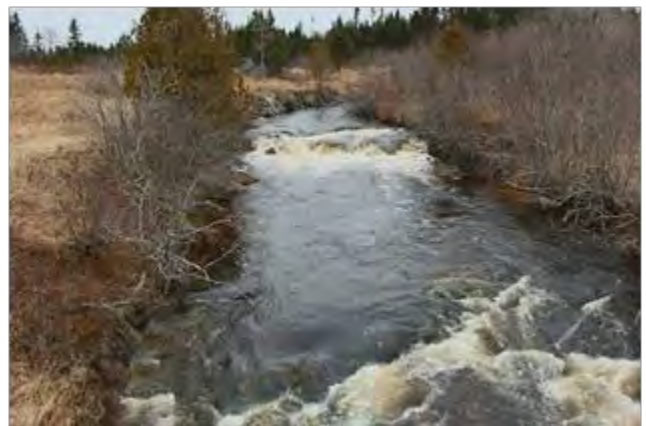
Figure 5: Pocologan sample sites (upstream on left).

Water temperatures at the up and downstream sites of the Pocologan River were similar to those recorded in 1994-1996 and well within comfortable limits for aquatic life, although they were higher upstream in 2014 during the early summer months. Dissolved oxygen has improved since 1994-1996 (Table 2); 8.0 mg/L upstream and 9.4 mg/L downstream, with less favorable levels recorded in mid-June. Overall, pH levels remain relatively the same since the 1994-1996 study. During early summer and late fall of 2014/2015, especially at the upstream site, pH levels were found to be below optimum. Turbidity levels were consistent with those recorded 20 years. Turbidity remained below 2.5 NTU with the exception of a sample in mid-September at the downstream site which reached 7.4 NTU following a precipitation event.

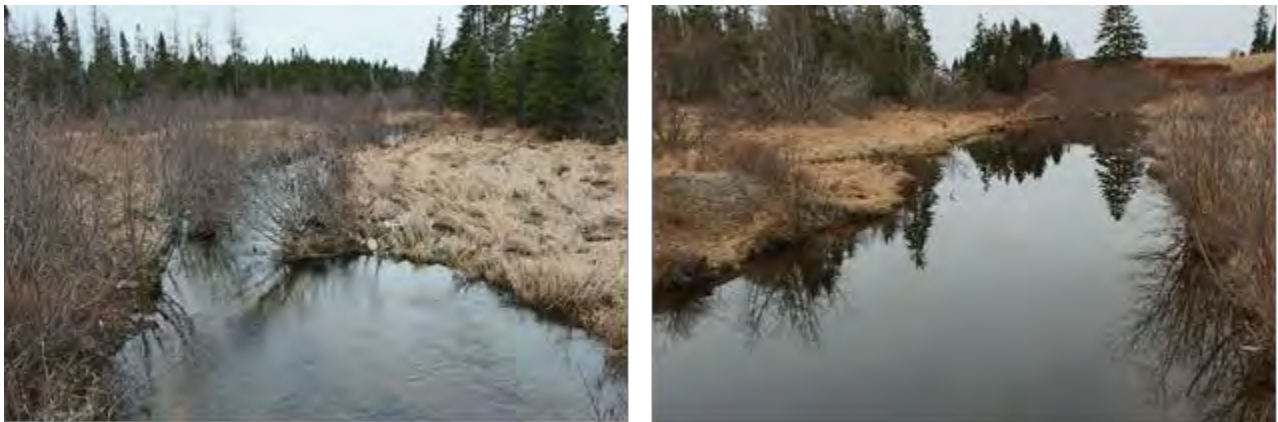
Figure 6: Cripp's Stream sample sites (upstream on left).

Cripp's Stream continues to be a very cool stable aquatic environment as was reported in 1997 and has seen improvements in conditions. Although water temperatures increased by approximately 2°C since 1994-1996 (Table 2), they remain low, ranging between 7.5°C and 14.5°C. Cool water temperatures kept dissolved oxygen levels high throughout the sampling period – averaging 10.7 mg/L – and were significantly higher compared to levels seen in 1994-1996 (Table 2). The pH levels slightly improved from 1994-1996, remaining near neutral throughout the sampling period. Overall, turbidity was generally higher in 2014/2015; however, these levels remained (1.38NTU) well within the recommended long term turbidity guideline of 2NTU (Canadian Council of Ministers of the Environment, 2002).

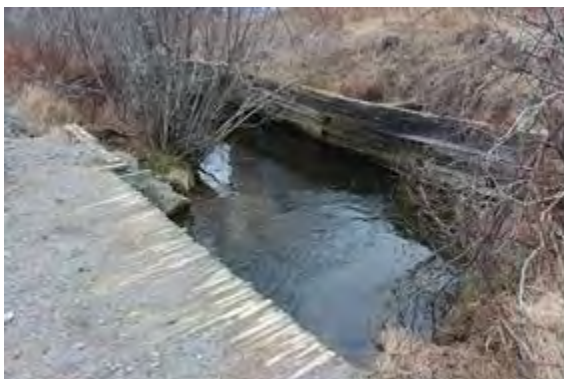
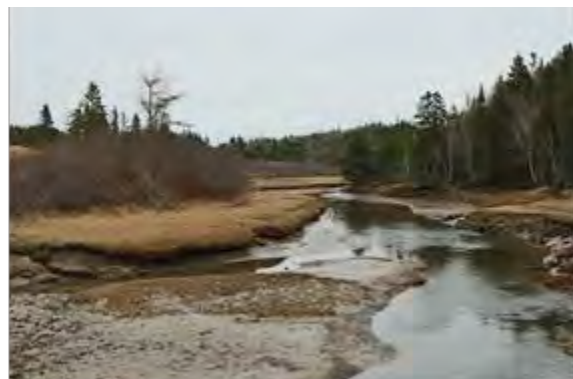
Figure 7: Buckman's Creek sample sites (upstream on left).

The results for the up and downstream sites for this small waterway were very similar and suggest a steady environment for aquatic life. The downstream site serves as a tidal inlet to Beaver Harbour and is periodically affected by increased salinity. The rise and fall of the tides have left the banks at this site muddy and exposed with little buffer zone, though this does not appear to significantly affect the results of the parameters tested. Water temperatures ranged from 5.9°C to 16.2°C throughout the sampling period and were on average 2.1°C higher than in 1994-1996 (Table 2). Despite slightly higher water temperatures in 2014, dissolved oxygen levels were greater compared to the previous study averaging 11.0 mg/L (Table 2). The pH levels were slightly higher in 2014 (Table 2), with both sites being near neutral throughout the sampling period. Turbidity levels at both sites remained within the acceptable range, with the exception of a sample in November 2014 at the downstream site that reached 8.79 NTU following a precipitation event the previous night. This was also the only sample taken at the downstream site during mid tide as the water flushed out of the inlet suspending sediment from the muddy banks upstream.

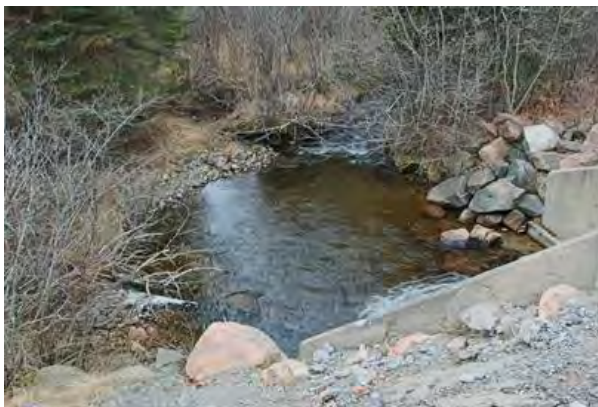
Figure 8: Mill Stream upstream sample site

Compared to 1994-1996, Mill Stream water temperatures were lower during the 2014-2015 portion of this study, ranging between 11.1°C and 14.6°C. This resulted in higher dissolved oxygen levels, averaging 11.2 mg/L (Table 2). The pH levels were consistently higher, and closer to neutral, at both sites compared to 1994-1996 (Table 2). Although turbidity levels were slightly higher than those reported in 1994-1996 (Table 2), they remained below 1 NTU throughout the sampling period, with the exception of the downstream site in November 2014 and June 2015 where levels hit 2.1 and 2.48, respectively; these values remain well within the acceptable range. Overall, this stream appears to be in excellent conditions for all usage as previously stated in the 1997 report. In 2014 samples were not collected from the upstream site of Mill Stream after early September because of the site's remote location and a personal injury sustained by the project's field staff.

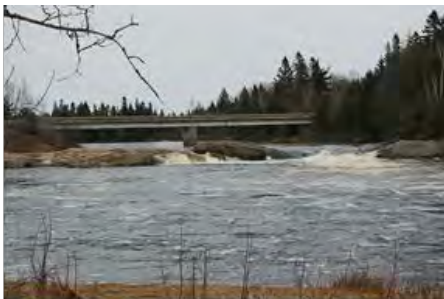
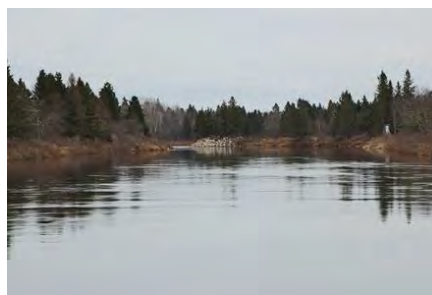
Figure 9: Magaguadavic sample sites (upstream on left).

Water temperatures at both up and downstream sites peaked in July of 2014, reaching dangerously high levels of over 25°C; however, warm water temperatures during the summer months cooled relatively quickly in September. Water levels during the summer of 2014 in the Magaguadavic River were lower than recently observed, which likely correlated with increased water temperatures. Water temperatures during the summer of 2015 remained relatively constant and did not exceed 22.5°C. Despite the aforementioned temperature peak in 2014, water temperatures remained similar to those recorded in 1994-1996. Dissolved oxygen levels were typically greater compared to 1994-1996 (Table 2) and remained above 7 mg/L throughout sampling. The pH levels were consistently close to neutral, which is an improvement since 1994-1996. Turbidity levels were low and coincide with those reported in 1994-1996, with the exception of an isolated spike in November 1995. Unfortunately, no data was collected for the up-stream section of the Magaguadavic River in 1996.

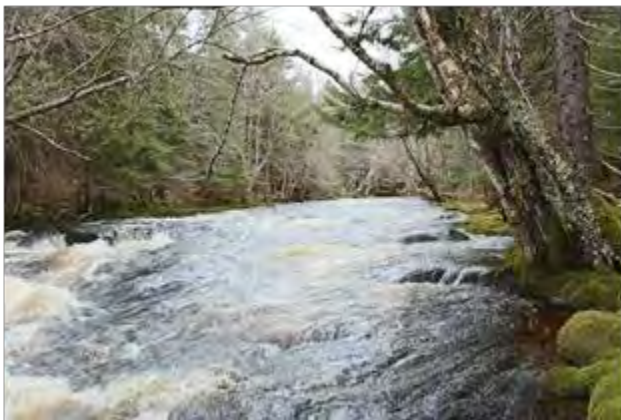
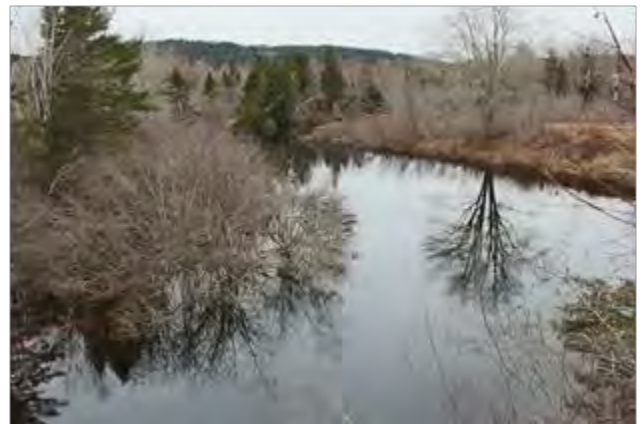
Figure 10: Linton Stream sample sites (upstream on left).

Water temperatures at the up and downstream sites peaked in July 2014 reaching close to 24°C, but settled to comfortable temperatures through the remainder of the sampling. Overall, water temperatures were consistent with 1995-1996 values. Dissolved oxygen levels were typically greater than those recorded in 1995-1996 (Table 2), though well within the acceptable limits for aquatic life, ranging between 6.6 and 11.2 mg/L. The pH levels were consistently greater and closer to neutral compared to 1995-1996 (Table 2). Overall, turbidity remained consistent with 1995-1996; however, at the down-stream site, turbidity was much higher than in 1995-1996. An odd “fishy” odor was regularly noted when collecting samples from the upstream site, which is not surprising considering the nearby fish hatchery. The average turbidity levels of 2014/2015 were 2.21NTU which is above the long term turbidity guidelines proposed by the Canadian Council of Ministers of the Environment. Samples were not collected from Linton upstream after early September 2014 due to difficulty accessing the site following a personal injury sustained by ECW field technician.

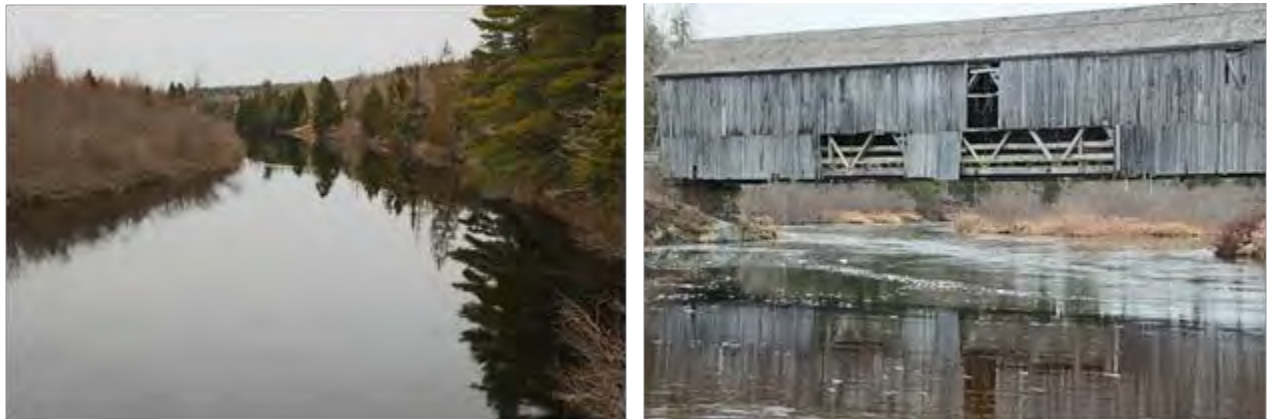
Figure 11: Digdeguash sample sites (upstream on left).

Water temperatures in the Digdeguash River were relatively the same as observed 20 years ago, and were generally higher downstream compared to upstream throughout the sampling period. Similar to the 1997 report, water temperatures rose in July and August before cooling with the fall weather. In July and August of 2014 and 2015, the downstream site reached close to 25°C. Dissolved oxygen levels were consistent with 1994-1996 levels and well within the acceptable limits for aquatic life, with the exception of two drops to 5.9 mg/L in July 2014 at the upstream site, and during September 2015 at the downstream site. The pH levels were higher and consistently closer to neutral compared to 1994-1996 levels that tended to be below 6 (Table 2). Turbidity levels were greatest at the downstream site but remained below the maximum optimal level of 5 NTU. Turbidity at the upstream site was more stable and did not exceed 1.0 NTU. Overall turbidity levels remained the same as in 1994-1996.

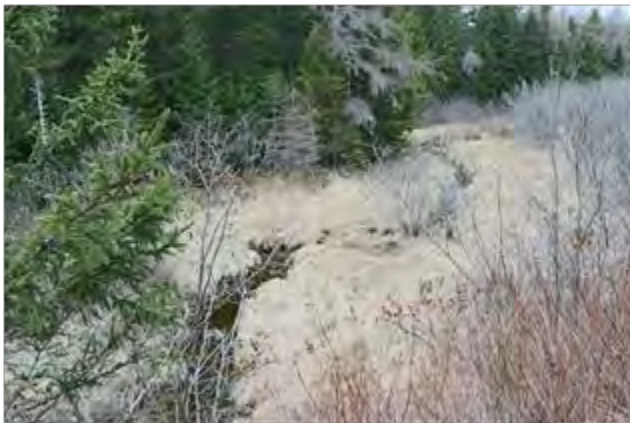
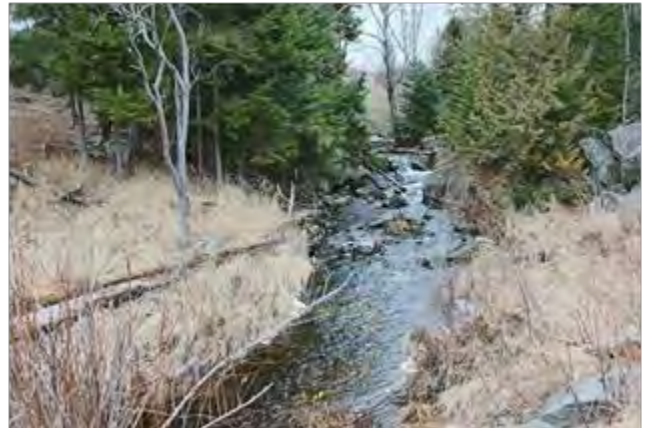
Figure 12: Big Meadow Outflow sample sites (upstream on left).

Water temperatures were generally higher upstream, which likely explains the lower dissolved oxygen levels recorded at the upstream site, which ranged from 5.9 to 11.6 mg/L. Dissolved oxygen levels improved since 1994-1996 (Table 2) averaging 8.2 and 8.8 mg/L at the up and downstream sites, respectively. Overall, pH levels improved since 1994-1996 (Table 2). The pH levels were higher and closer to neutral at both sites compared to 1994-1996 and remained near or within the acceptable range throughout the sampling period. Turbidity levels significantly decreased since 1994-1996 (Table 2). Turbidity levels were lower in the upstream site and relatively even downstream throughout the sampling period compared to 1994/1995, and remained within the recommended guideline for all water usage.
